Americans with Disabilities Act Self-Evaluation and Transition Plan

Prepared by: DICATOR DICATOR Project No. 1711.0016.00

FINAL VERSION Project No.

Project Support Provided by: JANUARY 2020

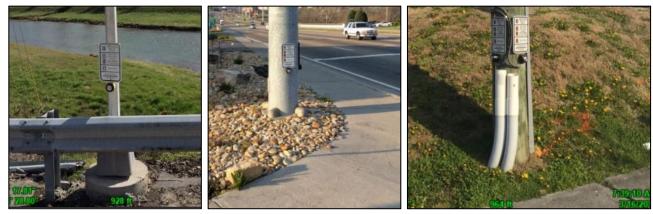
• Not all pushbuttons were 2" min. diameter and some were located outside the 36-48" height required by MUTCD.

Example of pushbuttons that are not located on an accessible route.

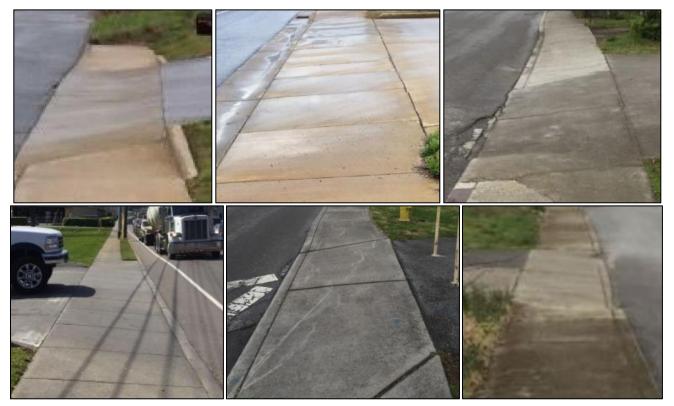
driveway without consideration of the resulting cross slope of the PAR. Many driveways are built through the sidewalk, with a severe cross slope presented to pedestrians crossing the driveway. In many instances, a vertical level change (curb) is constructed at the edge of the sidewalk in an apparent attempt to not have to perform work on sidewalk panels adjacent to the driveway.

Examples of driveway transitions at the PAR that introduce severe cross slopes and/or vertical elevation changes.

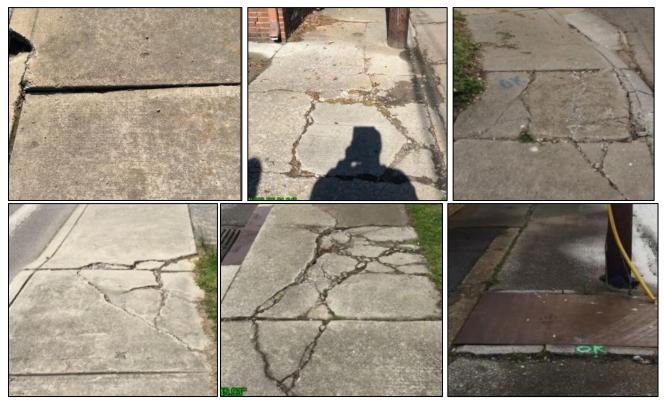
In general, newer sidewalks are relatively free of cracks, spalling, and displacements. Sidewalks in the Downtown and surrounding areas tended to be older and exhibit more surface condition concerns. In most areas that exhibited issues with displacements, surface condition, or changes in level, there were other issues (e.g., cross slope). Tree roots can cause heaving of sidewalks, but was uncommon in the City.

Examples of displacements, separations, and pavement in poor condition in need of maintenance.

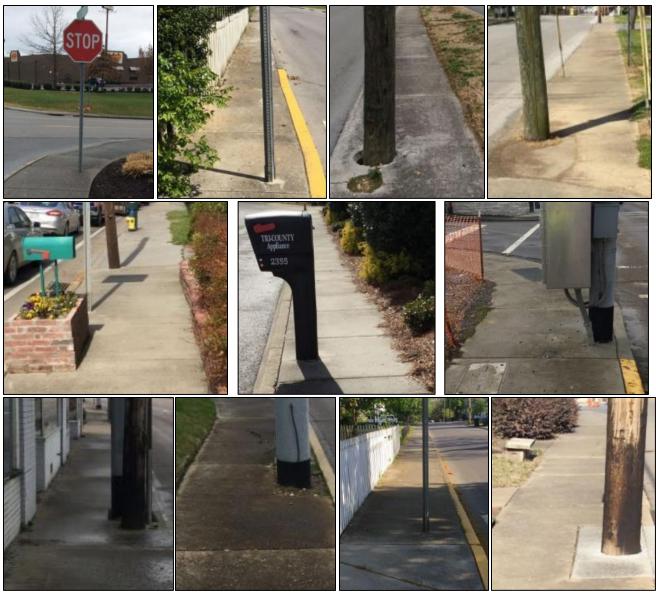
Examples of obstructions of the PAR that reduces the width to less than 48".

Fixed obstructions may be costly to address as they generally occur with utilities and may require relocation or purchase of right-of-way from adjacent landowners. For these items, a work-around solution is often preferred. These may include widening a small portion of sidewalk where possible or providing an equivalent alternate route. Providing a narrow area of tree lawn between the curb and sidewalk can assist by providing an area for items such as signs and mailboxes to be placed without obstructing the PAR and can also assist with resolving issues for temporary items like trash and recycling containers.

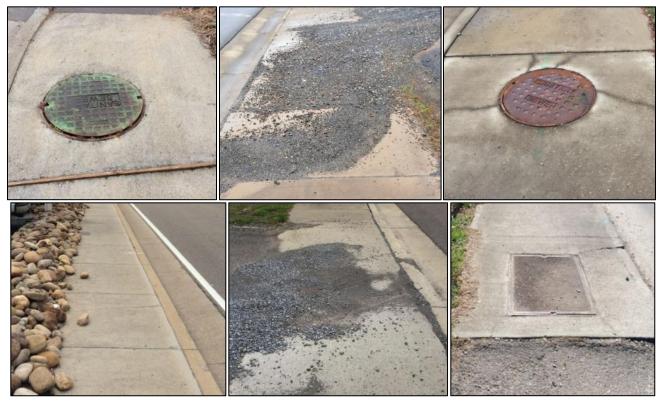
Examples of utility structures and debris along the PAR that can present issues for disabled users.

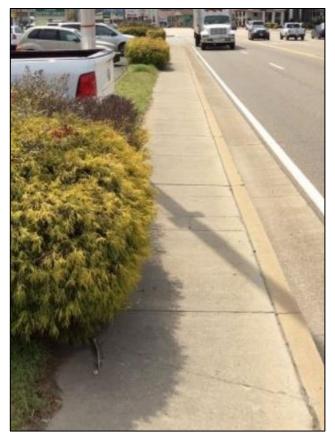
Example of overgrown vegetation that reduces the PAR width to less than 48".

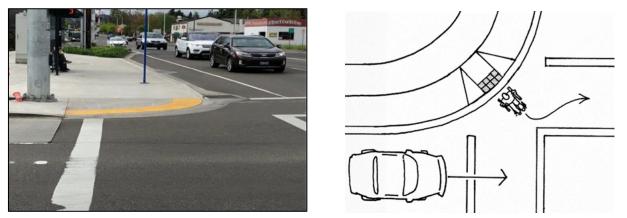
Diagonal blended transition (left) and diagonal perpendicular ramp (right). Both provide access to street crossings of more than one direction and are no longer permitted by PROWAG per R207.1.

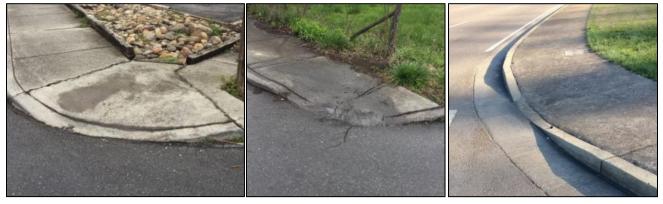
Examples of curb ramps that are less than the minimum 48" width required.

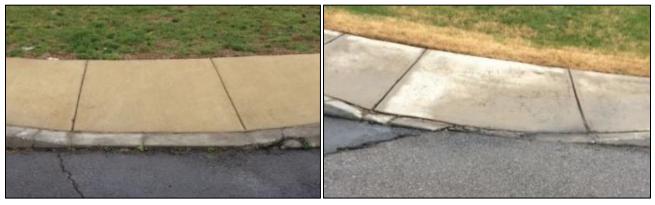
To provide a compliant 8.33% maximum running slope for a perpendicular ramp for a typical 6" curb, the distance required from the grade break to the top of the ramp is 6 feet minimum, at which point a minimum 48" top landing is required. In many areas the running slope complies but there is no landing or TS provided because of the lack of depth.

Curb ramps with excessive running slopes, typically severe slopes that exceed 10%. These ramps also exceed the counter slope requirements.

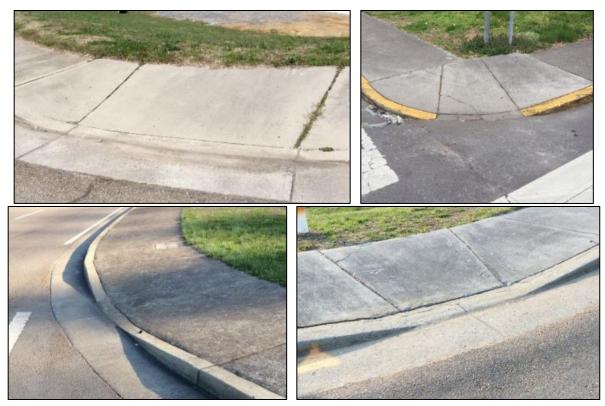
Within the City, there are a high number of primarily perpendicular curb ramps that do not provide compliant turning spaces. These locations typically are located where there is not adequate room to construct a perpendicular ramp and results in no turning space being provided. Wheelchairs attempting to use these ramps would be in danger of tipping over when attempting to turn. This was the most prevalent high priority issues to address with curb ramps in the City. As illustrated in the examples shown, curb ramps with non-compliant turning spaces often have other non-compliance issues. Parallel ramps with non-compliant turning spaces were often highly usable.

Example of curb ramps that lack a compliant turning space.

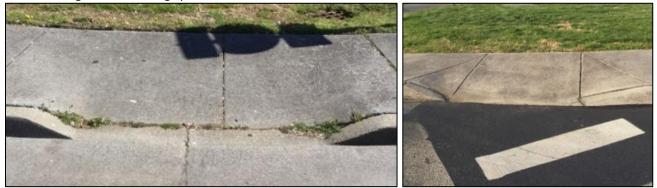
Example of curb ramps that have non-compliant flare slopes.

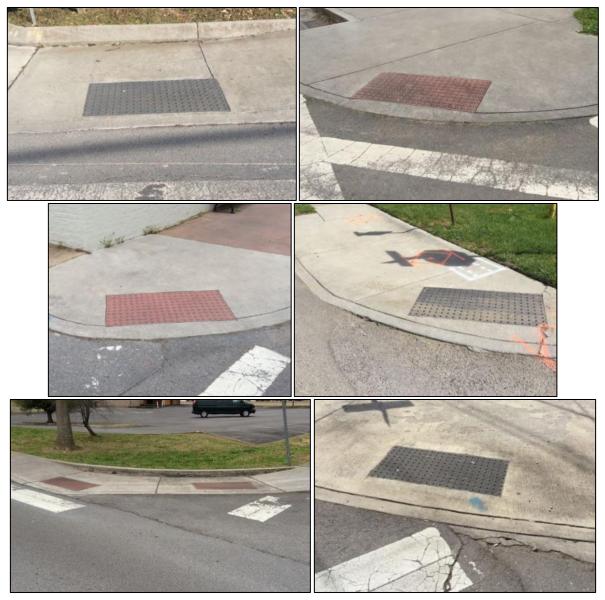
there were a number of recently constructed ramps with DWs installed incorrectly, with the most common errors being DWs that were not full width of the ramp or oriented in a way that does not provide a full 24" depth for the entire ramp width.

Example of curb ramps with detectable warnings that are not full width of the ramp.

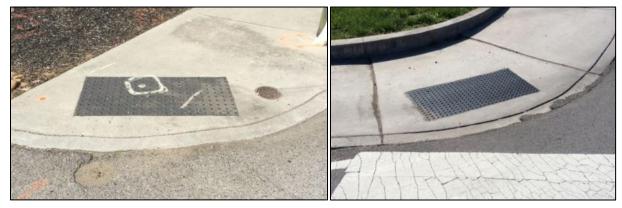
DWs that are oriented poorly and are not 24" depth in entire direction of pedestrian movement.

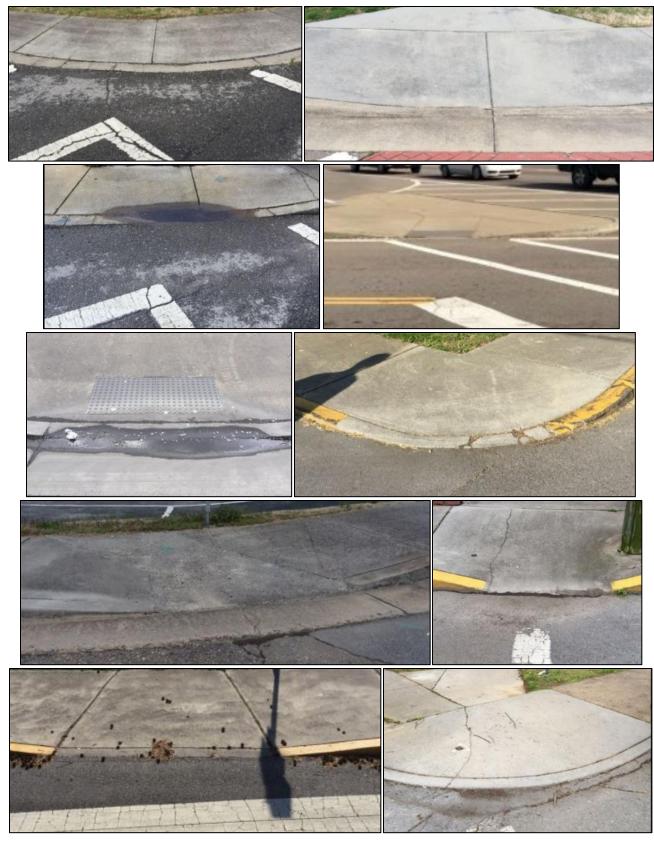
DWs were provided at a surprisingly low proportion of existing curb ramps. There were numerous locations where curb ramps have been recently installed or reconstructed without DWs. In addition,

Curb ramps lacking DWs as required or which have low contrast.

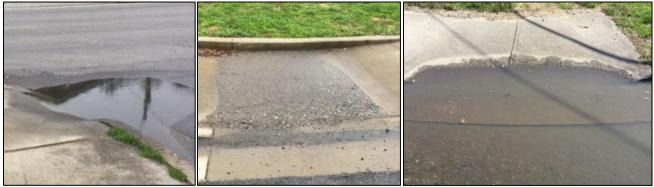
The self-evaluation noted a number of locations with either standing water within the curb ramp at the time of the evaluation or deposits of sediment, indicating that standing water is common. In some cases, the poor drainage is a result of changes to the low point in the gutter from an asphalt overlay. In others, drainage was either not considered adequately during design of the roadway or was not constructed according to the plans.

Examples of curb ramps with drainage issues and/or evidence of regular ponding, with sediment deposition.

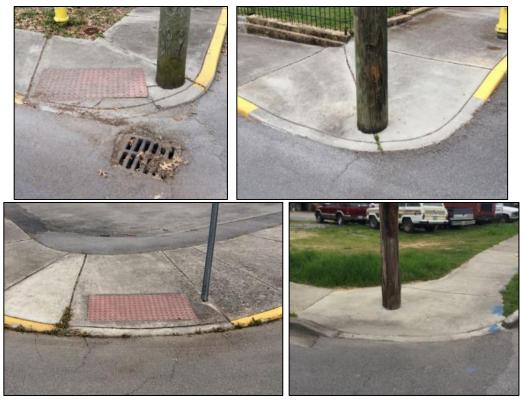
Obstructions that were observed included light and utility poles, sign posts, hydrants, and utility cabinets. In most cases, these obstructions encroached on the clear width of a turning space though some were located on the ramp run. Some obstructions could be worked around when curb ramps are reconstructed, but there are several that do not have an easy solution due to lack of ROW and other significant constraints.

Examples of curb ramps with obstructions at turning spaces, on the ramp, or immediately adjacent to either.

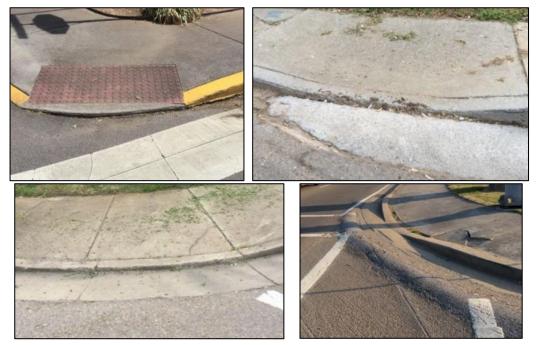
Vertical discontinuities were extremely common, with the most common issue being located at the gutter pan. Some discontinuities were several inches high. Other issues were observed at displaced cracks in the pavement, at the top of the ramp at the TS, or raised utility structures.

Examples of curb ramps with vertical discontinuities that exceed ½" at the curb, on the ramp, or the TS.

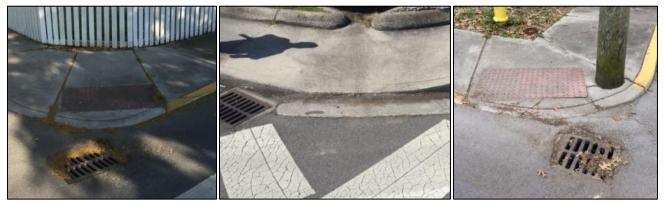
Horizontal openings were not common, but included drainage structures located within clear spaces and cracks that have separated to exceed $\frac{1}{2}$ ". Some storm structures with $\frac{1}{2}$ " openings are not oriented such that the openings are perpendicular to the primary path of pedestrian travel.

Examples of curb ramps with horizontal opening greater than ½" on the ramp or the clear space.
