Americans with Disabilities Act Self-Evaluation and Transition Plan

Prepared by: DICATOR DICATOR Project No. 1711.0016.00

FINAL VERSION Project No.

Project Support Provided by: JANUARY 2020

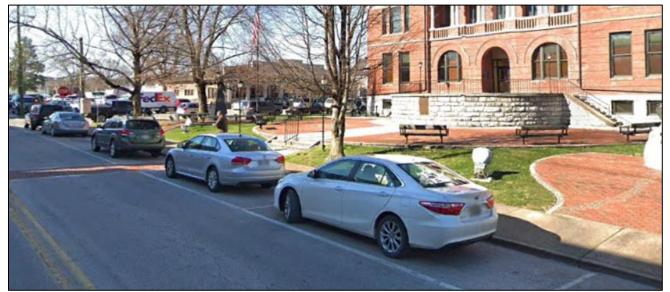
Google Earth Streetview image of parking on the east side of the Sevier County Courthouse.

Providing spaces may be as simple as providing pavement markings and signage. Other areas may require regrading and repaving of the parking space to meet slope requirements, and/or installation of accessible curb ramps where none is provided adjacent to the proposed space. It is important to evaluate the highest

use destinations in the downtown to determine the most desired location for accessible on-street spaces that can meet slope and curb ramp access requirements. If the most desired location is not able to provide compliant slopes, which is likely the case in many areas, the accessible on-street parking spaces should be located as close as possible to the desired location.

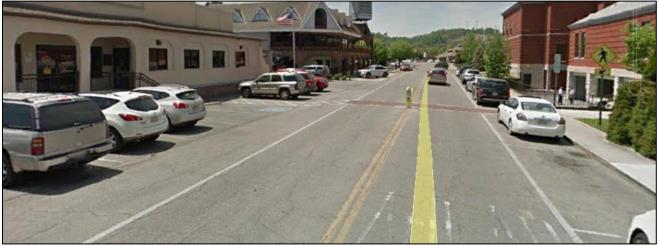
Google Earth Streetview image of parking on W. Bruce Street. The north side is public parking, south side parking was assumed to be for the respective sites since only a portion of the parking is in the public ROW.

Each block faced surveyed should be analyzed to determine the most logical placement of the required parking spaces. Priority should be given to those areas serving local government offices, especially the County Courthouse, and facilities and highly used retail and commercial places and placed to offer the shortest accessible route to such services. In some cases it may be beneficial to relocate required spaces nearer to higher use facilities rather than distribute the spaces throughout the block.

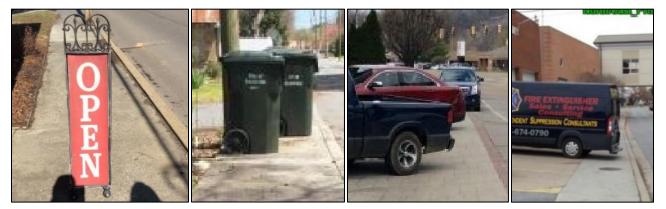
Temporary obstructions include cars in parking lots overhanging the PAR, trash and recycling containers, and outdoor dining tables and chairs.

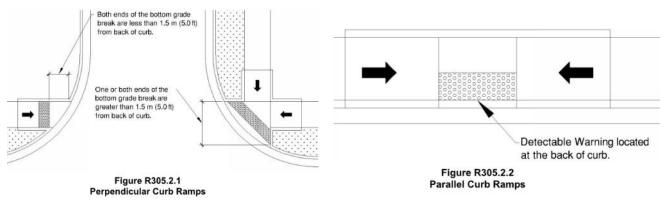
DWs were provided at a surprisingly low proportion of existing curb ramps. There were numerous locations where curb ramps have been recently installed or reconstructed without DWs. In addition,

there were a number of recently constructed ramps with DWs installed incorrectly, with the most common errors being DWs that were not full width of the ramp or oriented in a way that does not provide a full 24" depth for the entire ramp width.

Example of curb ramps with detectable warnings that are not full width of the ramp.
